# Bulwell Forest Ward

## Road Safety Study

Nottingham City Council Reference no: ACF238

Issue 1 – 13/12/2016

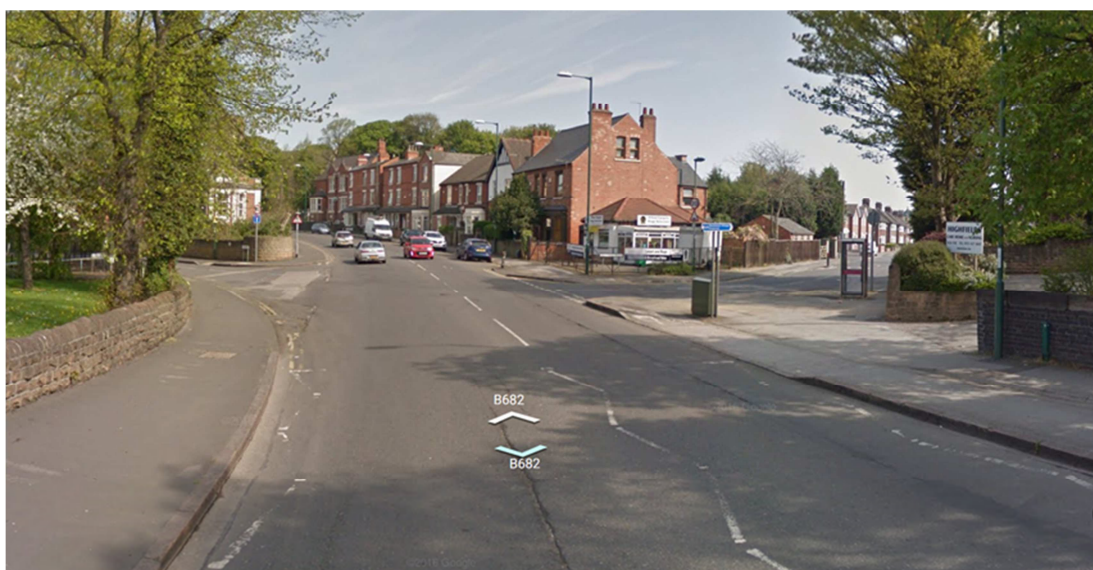
# **1. Highbury Road / Station Road / Cantrell Road**

- The serious accident shown occurred on 13/02/2015 on a Friday night at 23.07pm during wet conditions. A car being driven north along Highbury Road lost control and skidded into the opposite carriageway, collided with a car travelling south. A bus travelling behind vehicle two was also forced to brake suddenly causing a passenger to fall. The accident resulted in three slight casualties and one serious casualty for the passenger of vehicle two.

- Shunt accident as a vehicle slowed to turn right into Cantrell Road from Highbury Road.
- Shunt accident as vehicle travelling south along Highbury Road stopped to turn right into Station Road.

- Shunt accident as vehicles travelling north along Highbury Road slowed.
- Vehicle turning right from Cantrell Road onto Highbury Road, alleged a northbound bus stopped to allow the vehicle out and collided with another car travelling south along Highbury Road.

- 2 x Vehicle turned right out of Station Road across the path of vehicle two travelling north along Highbury Road.
- Vehicle parked on nearside kerb opened passenger door onto cyclist overtaking vehicle.

Five of the seven accidents at this junction took place in wet conditions and four of the accidents involved shunt and skidding as contributory factors, site observations show that the carriageway in this area could benefit from resurfacing particularly around the junction mouth of Station Road. This type of accidents also suggest that traffic speeds along Highbury Road may be relatively high, the contributory factors; failing to judge other persons path or speed and careless, reckless or in a hurry were cited in the majority of the accidents. Positively only one accident at this junction involved a vulnerable road user (pedestrian, cyclist, motorcyclist).

Site observations show that visibility for vehicles turning out of Station Road is poor in both directions due to the alignment of the junction. It was also noted that vehicles turning right into Station Road from Highbury Road frequently turn early into the junction mouth putting themselves in the wrong directional lane of traffic. Station Road also appears to be well used by U-turning vehicles.

The large width of the junction mouth of Station Road contributes to drivers making poor manoeuvres in and out of the junction. The running lanes on Highbury Road through this junction are also relatively wide increasing speeds along Highbury Road but also the speed in which movements in and out of the junction are made.

There are a number of highway improvements which could be made at this junction such as; narrowing and realigning the junction of Station Road whilst upgrading the dropped crossing. Resurfacing and relining the carriageway and narrowing the junction radius of Station Road. Consideration could be given to providing right turning areas on Highbury Road and visually narrowing the carriageway with the relevant lining and hatching.

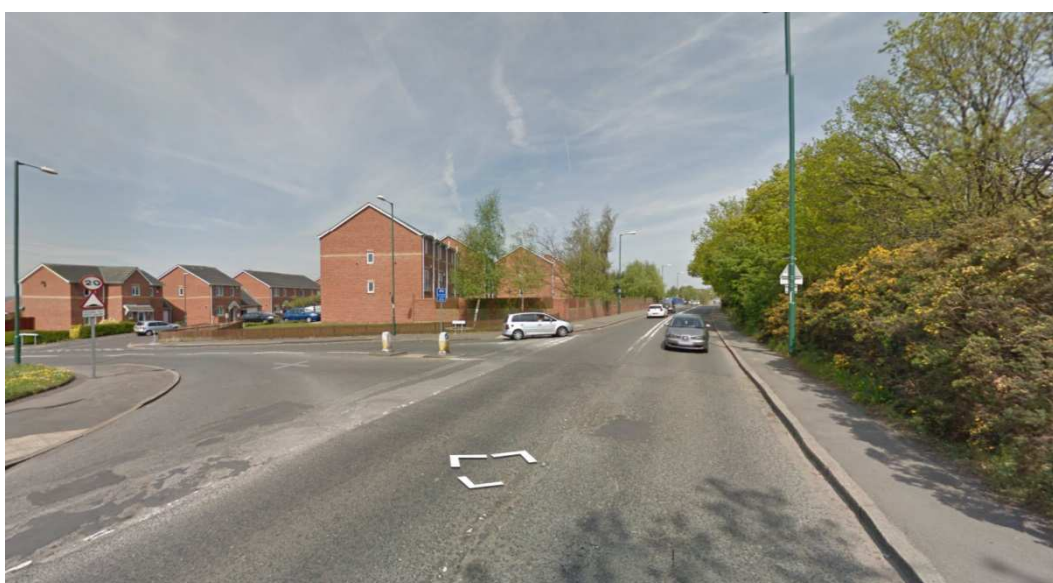
## 2. Hucknall Road junction with Kersall Drive

- Serious accident at this location occurred on 9<sup>th</sup> November 2014 at 15.49, a car travelling south along Hucknall Road collided into the rear of a second car waiting to turn right at the junction of Kersall Drive. The passenger of the second car sustained serious injuries.
- Motorcycle lost control travelling north-west at the approach to Kersall Drive and the rider fell.
- Stolen vehicle travelling south along Hucknall Road in heavy traffic collided with the rear of traffic queuing at the junction as it attempted to turn right into Kersall Drive.
- 2 x Vehicle travelling south along Hucknall Road in slow moving traffic shunted into vehicle two.
- Vehicle one turned right into Kersall Drive across the path of vehicle two travelling north along Hucknall Road.
- Vehicle one collided with rear of vehicle waiting to turn right into Kersall Drive.

- Vehicle one turned right out of Kersall Drive and collides with vehicle 2 travelling south along Hucknall Road.

The junction mouth of Kersall Drive is very wide as it joins Hucknall Road perhaps resulting in vehicles carrying speed through into the junction when traffic flow allows. The majority of accidents at this junction relate to conflict on Hucknall Road as vehicles wait to turn into the junction with five of the seven accidents involving shunts.

There is possibility at this location for the junction of Kersall Drive to be narrowed considerably to prevent vehicles carrying speed through into the junction which could help to address the turning manoeuvre accidents. This would also shorten the crossing distance for pedestrians travelling along Hucknall Road. The junction would also benefit from relining. Consideration could be given to applying a length treatment to Hucknall Road to address the shunt accidents with options to reline, resurface and potentially reduce speeds along the length. A feasibility study to analyse this junction would cost approximately £4250.

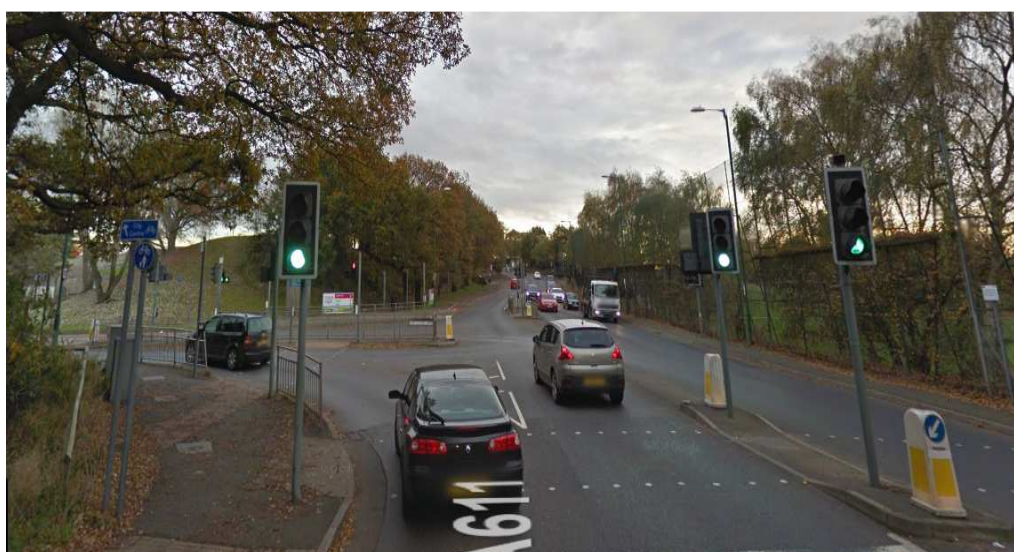
### 3. Hucknall Road / Top Valley Way Junction

- The serious accident occurred on 29th February 2012 at 15.30pm involving a car travelling north on Hucknall Road approaching the junction with vehicles queuing in right turn lane, a pedestrian (12 year old school girl) travelling home from school crossed westbound on the crossing against the red man, between queuing vehicles and collided with car travelling north.

- Van completes late lane change to the straight ahead lane travelling south on Hucknall Road, and collided with side of vehicle travelling ahead.
- Car travelling north along Hucknall Road queuing to turn right, second car undertakes and turned right in front of vehicle one causing collision.

- 2 x Car travelling north on Hucknall Road, turned right into Top Valley Way across path of car travelling south on Hucknall Road.
- Car facing north waiting to turn right into Top Valley Way fails to see taxi travelling south and turned across its path causing collision.

The accident history at this location reflects the busy nature of the junction. There is only one accident involving a vulnerable road user which although unfortunately a serious accident involves misuse of the existing crossing facility. Of the five remaining accidents four involve vehicles turning right into Top Valley Way from Hucknall Road, this is a popular movement at this junction and site observations have shown that the road layout and visibility here are both good. On closer analysis of the right turn accidents all four include failing to look properly or failure to judge path or speed as contributory factors which suggests driver error is the cause of the majority of these accidents.

There are no further recommendations for this junction.

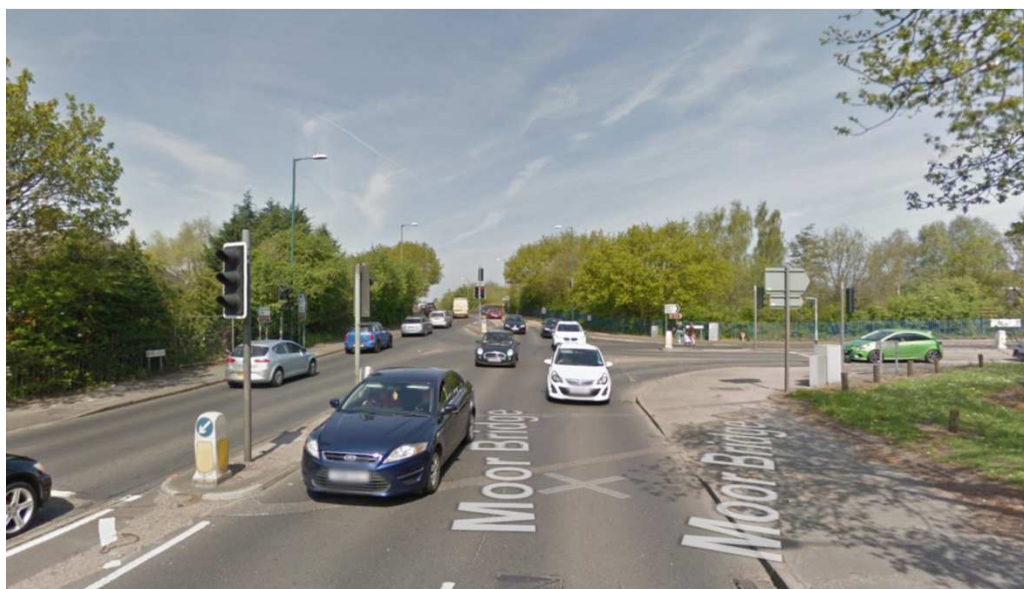
#### 4. Hucknall Road junction with Bestwood Road

- Motorcycle rider travelling north-west falls in slowing traffic for signalised junction.
- Car driver lost control and collides with central refuge travelling south east.
- Shunt accident with a motorcyclist and car both travelling south east stopped at signalised junction.
- Van turning left from Bestwood Road on green light collided with pedal cyclist travelling south east on Hucknall Road.
- Car turning left from Bestwood Road mounts pavement and collided with pedestrian waiting to cross.

The accidents show no real pattern at this junction. Unfortunately four of the five accidents involve vulnerable road users; two motorcycles, one pedestrian and one cyclist. The accidents, all taking place between 12.00pm and 7.35pm mainly appear to reflect the busy nature of this signalised junction. The pedestrian facilities at this junction could benefit from upgrading however this would not represent an accident saving based on the recorded injury accidents at this location.

Having observed the junction there are no immediate suggestions for remedial work without further investigations or a potential large scale junction improvement scheme.

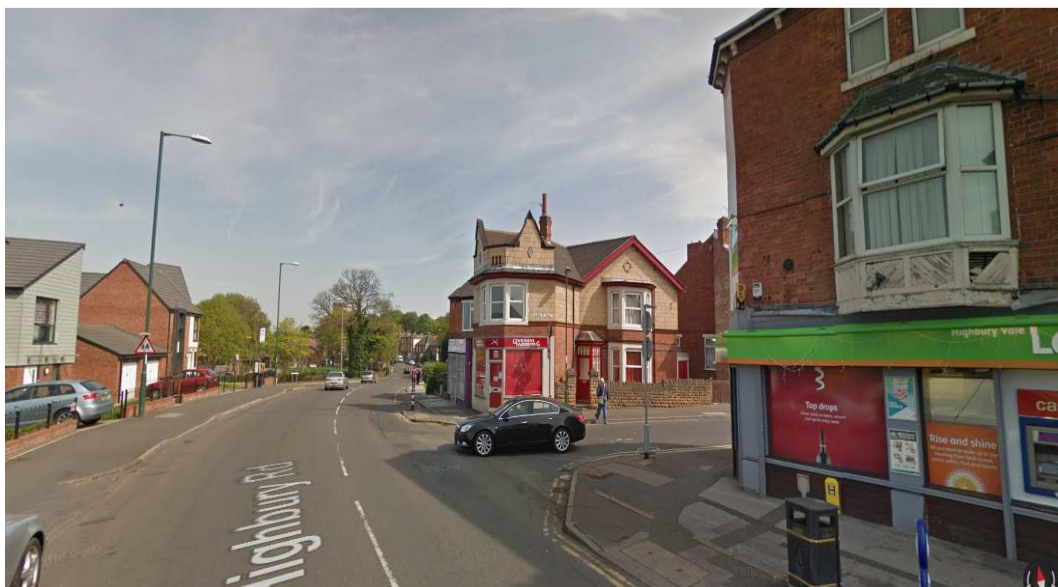
## 5. Highbury Road junction with Henrietta Street

- Car travelling south Highbury Road turned left into Henrietta Street and collided with pedestrian – 6 year old child crossing junction mouth of Henrietta Street.
- Car turning right out of Henrietta Street collided with pedestrian who has alighted bus and crossed behind bus just north of the junction, waiting in the centre of the carriageway.
- 2 x Vehicle turned left out of Highbury Road into path of car travelling south on Highbury Road.

This junction is in close proximity to problem site one (Cantrell Rd / Station Rd) and shares many of the same issues. Due to the road geometry visibility is extremely poor for vehicles turning in and out of Henrietta Street. Although a Stop Sign is provided at this junction the mandatory lining which should accompany Give Way and Stop signage is missing, this does not reinforce the requirement for vehicles to stop at this junction and also makes it unclear to

drivers where the most appropriate place to wait is. Visibility is further restricted for vehicles exiting Henrietta Street onto Highbury Road by vehicles, particularly larger vehicles parked in the parking bays to the left of the junction and in the area directly after the buildout to the right of the junction. The accidents at this junction demonstrate the poor visibility both of pedestrians as vehicles turn into the junction and of southbound traffic as vehicles turn out of the junction onto Highbury Road. The informal crossing points in the surrounding area of the junction are also poor, crossing from the dropped kerb outside of the Londis corner shop leads to the vehicular access to a Garage and the dropped kerb outside of the Hairdressers leads to the vehicular driveway of a residential property.

Visibility at this junction could be improved by utilising the existing build outs on Highbury Road either side of the junction and extending these around into the junction mouth to allow drivers to achieve better visibility of traffic travelling along Highbury Road. Moving the stop line of Henrietta Street forward to bring drivers vision in line with the edge of the parking bays. The provision of build outs would also improve pedestrian safety at the junction and allow for repositioned and upgraded dropped kerbs to be provided across the junction of Henrietta Street.

Ideally the existing parking bays on Highbury Road should be shortened to improve inter-visibility between traffic on Henrietta Street and Highbury Road however it is appreciated that parking is required in this area for the local shops. Consideration could be given to extending the existing buildout outside of the hairdressers north along Highbury Road to prevent vehicles parking as close to the junction but maintain the parking to the south of the junction for the businesses. Extending the buildout at this location would also allow for the provision of a joined up dropped crossing to serve the closely located bus stop on Highbury Vale providing an informal crossing point for those who choose not to walk to the formal crossing point further north along Highbury Road.

The junction would also benefit from relining particularly to emphasise the stop line and road markings for vehicles exiting the junction onto Highbury Road and to encourage appropriate road positioning and maximise visibility splays.

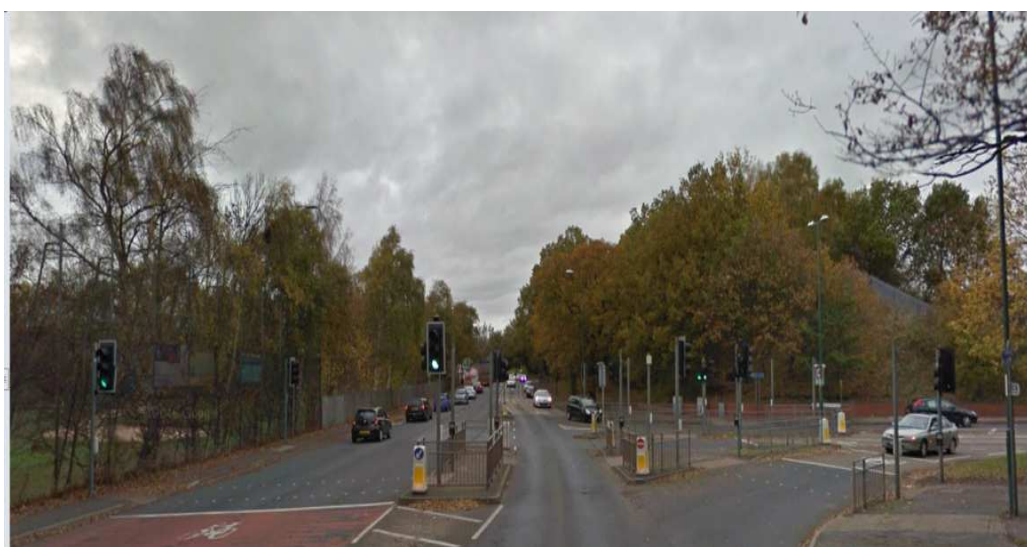
## 6. Hucknall Road junction with Bestwood Park Drive

- Car one travelling north Hucknall Lane turned right across the path of vehicle two travelling south.
- HGV travelling south on Hucknall Road, car waiting to turn right onto Bestwood Park Drive misjudges path of HGV and turned right causing collision.
- 2 x Two vehicles travelling north along Hucknall Road shunt due to heavy traffic.

The level of accidents at this location is relatively low for a busy junction of this nature and fortunately no vulnerable road users have been injured at this location. Considering the details of the accidents; two involve vehicles turning right across the path of vehicles travelling south along Hucknall Road. Visibility at this location is excellent meaning that drivers may be misjudging the speed of traffic along the road. Similarly vehicles travelling north have good visibility of queuing traffic ahead. Investigations have been carried out by our Traffic Signal Design Team with regards the provision of a right turn filter at this location however site observations have shown there is not an issue with traffic queuing to make the right turn manoeuvre as there is sufficient time within the existing phasing for vehicles to

complete the turn based on the current volume of traffic using this junction. Based on the traffic counts and accident data the site would not currently meet criteria to have a right turn filter provided.

It is suggested that the current level of accidents does not justify further investigation at a busy junction of this nature.

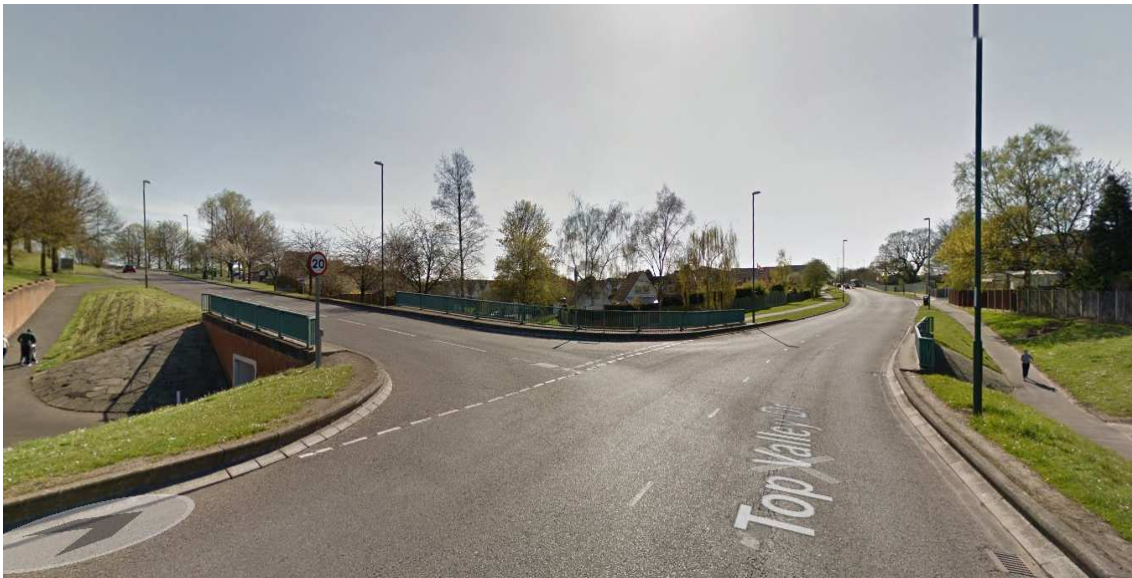
## 7. Top Valley Drive junction with Old Farm Road

- Car travelling north along Old Farm Road turned right onto Top Valley Drive across the path of car travelling west on Top Valley Drive.
- Car pulled out from Old Farm Road turning right collides with LGV travelling southwest on Top Valley Drive (LGV may have still had indicator on from roundabout).
- Car travelling north along Old Farm Road as it approaches junction is alleged that foot slips off brake onto accelerator and car overshoots junction colliding with car travelling west along Top Valley Drive.

All of the above accidents involve vehicles pulling out of Old Farm Road onto Top Valley Way, this would suggest that vehicles are carrying speed through into the junction and not stopping to give way correctly. The junction is wide and the downhill slope on the approach to the junction with a sunken footway and railings could all encourage higher speeds.

There is however excellent visibility in both directions along Top Valley Drive for vehicles exiting the junction of Old Farm Road. It is also interesting to note that all three accidents at this location took place in 2015 with there being no previous recorded injury accidents in the

previous 5 years at this location. All of the three accidents also took place in wet or icy conditions.

It is recommended that no further action is taken at this time but to ensure that accidents at this location are monitored.

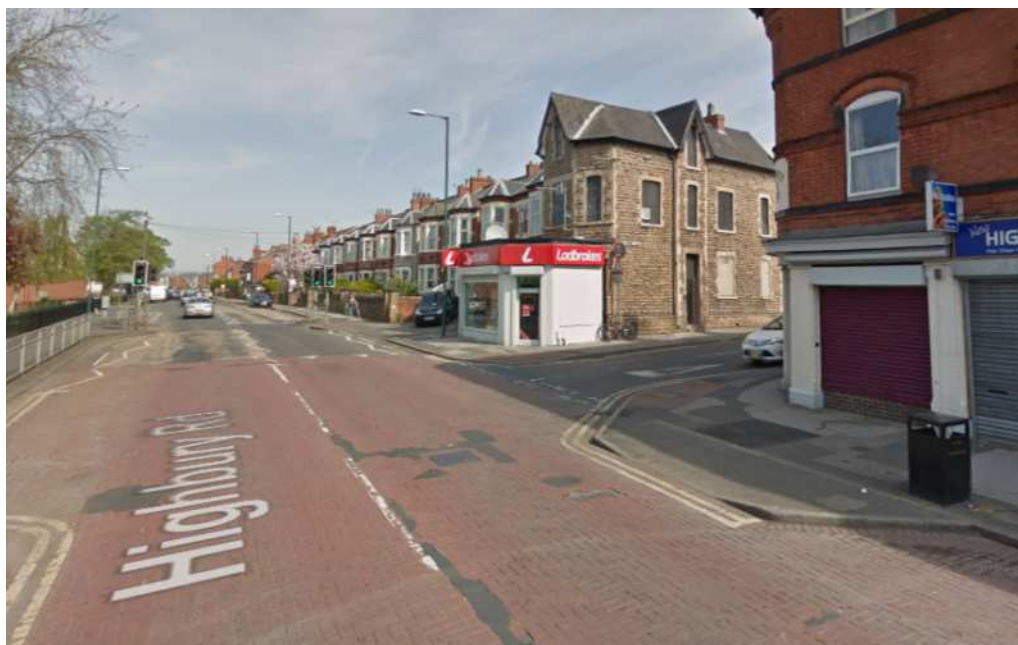
## 8. Highbury Road junction with Broomhill Road

- Car travelling north east on Highbury Road turned right into Broomhill Road collides car travelling south east on Highbury Road.
- Car travelling south east on Highbury Road turned left into Broomhill Road and collides with pedestrian crossing south eastbound who fails to look.
- Car travelling northwest on Highbury Road intending to turn right into Broomhill Road. Pedestrian stepped into carriageway intending crossing north east.

The junction is already part of a raised plateau for the Highbury Road shopping area, highlighted by the red surfacing which assists in lowering vehicle speeds. There is a high pedestrian footfall due to the Co-op addressed by the closely located pedestrian crossing. Although two of the accidents involve conflict between a pedestrian and vehicle in both instances the pedestrian stepped into the carriageway without looking, poor visibility due to the building line at the junction may have contributed to these accidents.

The dropped crossing at the junction could be upgraded to improve facilities for pedestrians.  
The junction could also form part of a route study on Highbury Road to reduce speeds as mentioned previously within the report on page 8.

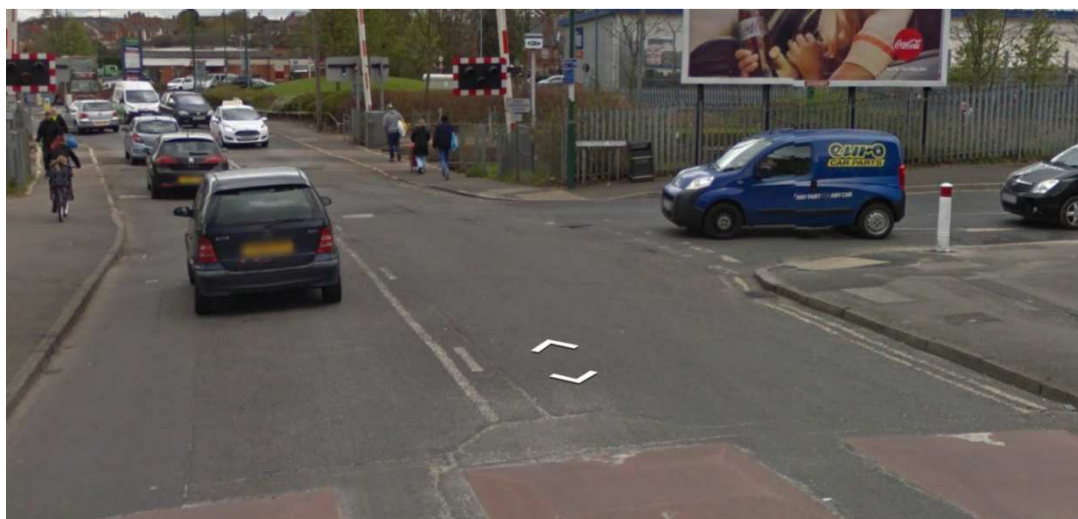
## 9. Bestwood Road junction with St Albans Road

- A serious accident took place on 5th January 2011 at 17.04pm. A car travelling west on St Albans Road turned right onto Bestwood Road and collided with a pedestrian crossing the junction mouth to the west, pedestrian sustained serious injuries.
- Vehicle travelling south west on Bestwood Road joined slow moving heavy traffic at junction shunt occurred.
- Vehicle travelling east on St Albans Road shunt occurs as vehicle waits to turn left into Bestwood Road.

This junction's close proximity to the level crossing and tram stop mean that there is often congestion and queuing traffic as well as a fairly high pedestrian flow, which is reflected in the accidents at this location. With regards to the serious accident involving a pedestrian crossing Bestwood Road and a vehicle turning right, inter-visibility between pedestrians and vehicles at this junction is generally good. Queuing, stationary traffic may mask some pedestrian movement at the junction and in this instance the contributory factors suggest that both car driver and pedestrian failed to look properly. Although there have been no reported injury accidents evidencing this there have been concerns raised by motorists

regarding near misses and non-injury accidents occurring where vehicles travelling west on St Albans Road overtake queuing traffic in order to turn right into Bestwood Road. This leads to potential conflict with vehicles turning left out of Bestwood Road. This is a similar problem for vehicles queuing on Bestwood Road waiting to turn left onto St Albans Road.

Further investigations would be required at this junction in order to determine possible remedial measures.

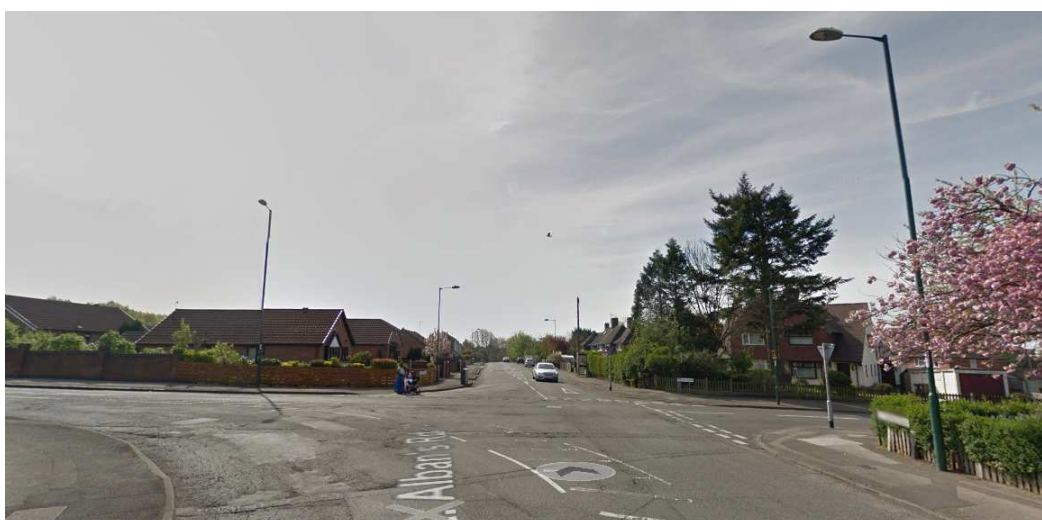
## 10. Kersall Drive junction with St Albans Road

- Motorcyclist travelling south east on St Albans Road lost control negotiating left hand bend onto Kersall Drive in the rain.

The geometry, layout and give way priorities at this junction are unconventional, however there is no accident record to support making changes to the current layout. The approaches to the give way at this junction are clearly signed and lined and visibility is adequate on all approaches.

There are no further recommendations at this junction.

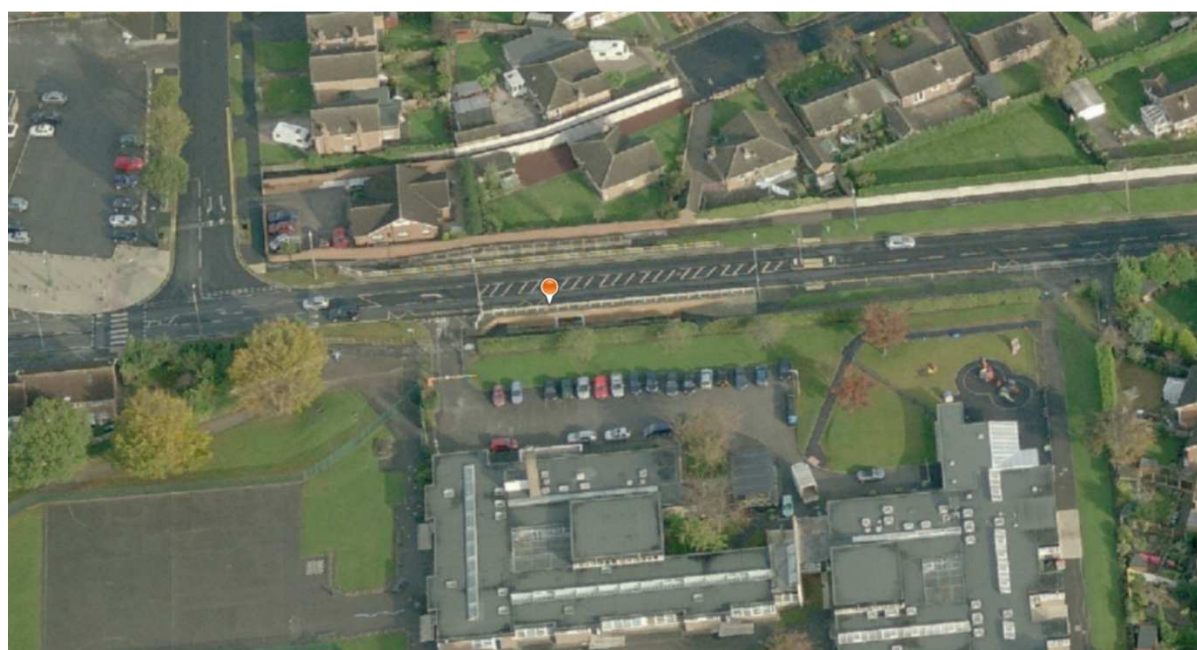
**11. Bestwood Park Drive West – Outside of Rise Park School**

- Car travelling west on Bestwood Park Drive, 14 year old pedestrian on his way to school stepped onto zebra crossing from drivers nearside.
- Motorcyclist travelling east Bestwood Park Drive West lost control crossed into opposite carriageway and collided with car travelling west.
- Car travelling west Bestwood Park Drive, pedestrian runs onto zebra crossing from drivers offside.
- Car travelling east approaching Brownlow Drive, starts to overtake unknown vehicle adjacent to Bus terminus misjudges distance and central refuge and mounted offside kerb and collided with telegraph pole.
- Taxi travelling east along Bestwood Park Drive, pedestrian pushing pushchair stepped onto zebra crossing and collision occurred.

It is concerning that three of the five accidents in this area outside of Rise Park School took place on the zebra crossing facility close to Brownlow Drive where drivers have clear visibility of pedestrians approaching the crossing. Two of the accidents involve vehicles approaching the crossing from the east and one from the west. A road safety scheme was completed here in 2008 where improvements were made to the zebra crossing. The zebra crossing is located on a raised plateau to reduce vehicle speeds on the approach and the crossing has been fitted with zebrite belisha beacons to increase the visibility of the crossing. There is also an operational School Crossing Patrol in position at this location to assist children in using the zebra crossing.

A feasibility study was carried out in 2007 as part of the road safety scheme investigations into the plausibility of signalling the junction of Brownlow Drive and Bestwood Park Drive incorporating signalised pedestrian crossings on all three arms of the junction into the design. The results showed that queue lengths on all approaches would increase and that pedestrian utility would decrease as pedestrians would have to wait for the green man to appear when demanded. On average with the observed traffic flows in the area at the time when the study was conducted the wait would be approximately 84 seconds, at present pedestrians arriving at the zebra crossing have immediate priority. Due to the high volume of pedestrians using this zebra crossing particularly during school pick up and drop off times it was felt that expecting pedestrians, and more significantly children, to wait over a minute was unsatisfactory and may lead to violations and an increased safety risk.

It is recommended that no further action is taken at this location at this time but that accidents continue to be monitored.

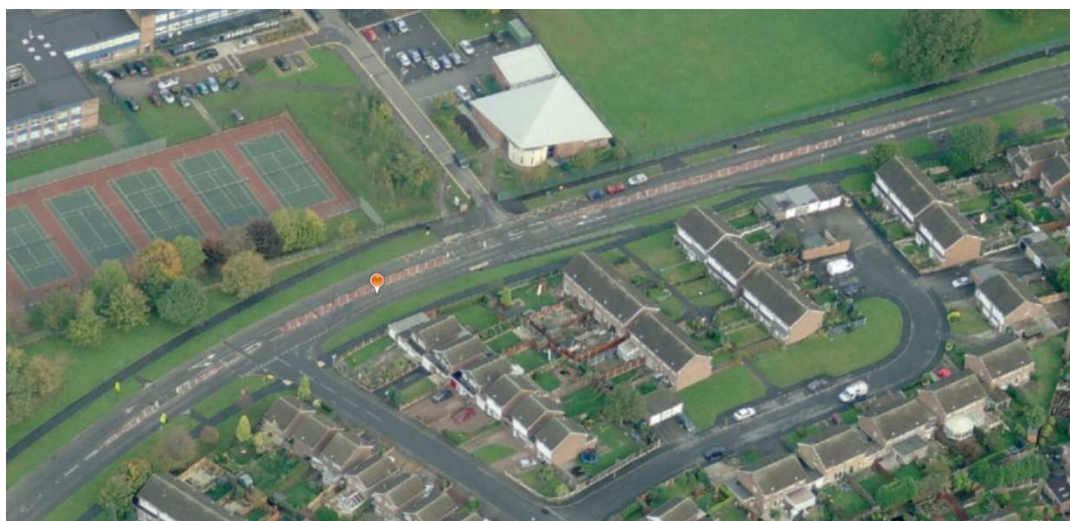
## 12. Top Valley Drive – Outside of Top Valley Academy

- One serious accident occurred on 30<sup>th</sup> April 2013 at 22.10 when a motorcyclist with pillion collided for unknown reasons with the central refuge travelling south west along Top Valley Drive, the passenger sustained serious injuries.

The stretch of Top Valley Drive outside of Top Valley School is part of a 20mph speed limit, there are also large flashing amber school signs on the approach to the school access and although the road is wide it is visually narrowed by the central refuges and hatching on carriageway. Residents have raised concerns that with no formal crossing point and parked cars in the area it is difficult for children to cross the road safely. School Keep Clear markings are in place directly outside of the entrance to the school to prevent parking during school morning and evening peaks and there is a pedestrian refuge provided. There has only been one serious reported injury accident within five and half years along this section of road which involved a motorcyclist losing control on the bend of the road, no other vehicles were involved in the accident.

The accident history alone does not justify further investigations at this location. However should it be felt that further pedestrian facilities are required at this location a feasibility study could be conducted to consider the provision of a zebra crossing at this location at a cost of approximately £4250. A parking study could also be undertaken to assess the existing parking levels in the area and consider whether further parking restrictions are required within the area at a minimum cost of approximately £1200 depending on the area under consideration.

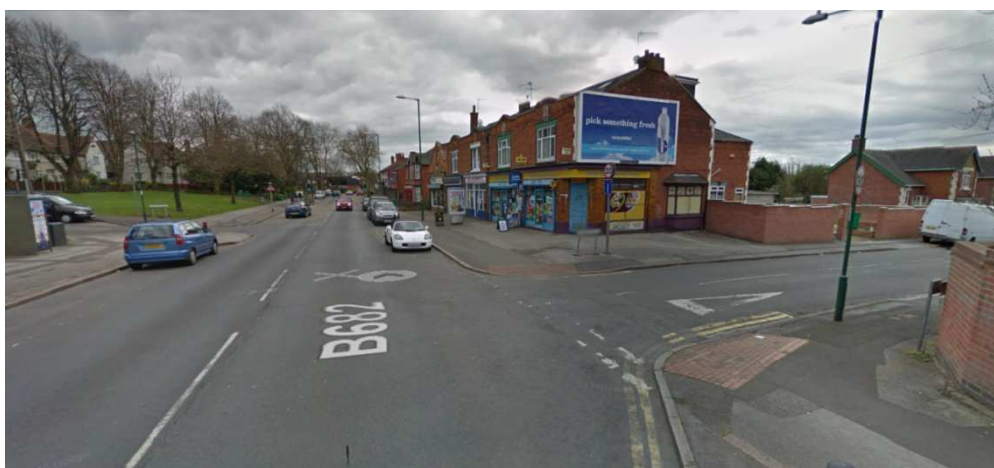
### 13. Highbury Road junction with Bedford Grove

- Car travelling north-west along Highbury Road swerved to avoid oncoming car and collided with nearside kerb.

The junction mouth of Bedford Grove is narrow, junction protection is in place to prevent parking on the junction itself although due to the convenience store on the corner parking takes place on the unrestricted sections of the road. The junction is built out to the south east which allows for improved visibility for vehicles exiting Bedford Grove onto Highbury Road. The one accident at this location involved a vehicle swerving to avoid another vehicle travelling along Highbury Road in an isolated incident. Similarly to neighbouring junctions along Highbury Road the alignment of the Give Way lining on Bedford Grove could be improved to increase visibility for vehicles exiting onto Highbury Road.

Road markings and lining could be realigned and refreshed, based on the accident history at this junction there are no further recommendations.
