NOTTINGHAMSHIRE
Fire & Rescue Service
Creating Safer Communities

VIREMENT REQUEST FOR REPAIR WORKS TO SDC FIRE HOUSE

Ollerton Fire Station
Structural Appraisal Report
Concrete Floor Slab Remedial Works

TUNSTALL
C O N S U L T A N T S
Civil & Structural Engineering Consultants
15 Grasmere Road, Beeston,
Nottinghamshire. NG9 3AQ
T: 07813 650464

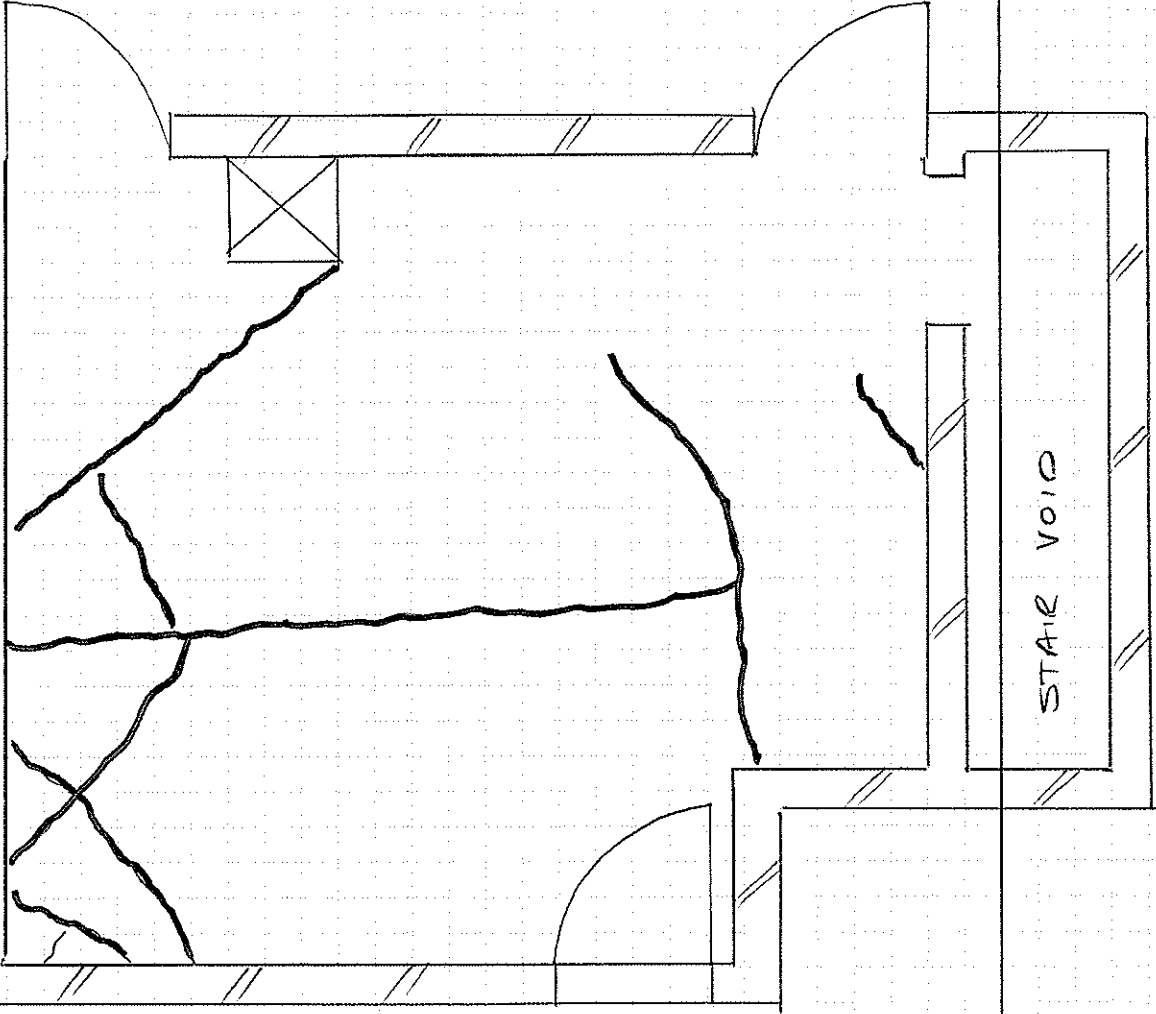
<p data-bbox="331 1566 843 1619"><u>FIRST FLOOR LAYOUT</u></p> <p data-bbox="331 1647 843 1692"><u>SHOWING CRACKING</u></p> <p data-bbox="331 1714 669 1758"><u>SCALE 1:50</u></p>

A visual survey was carried out of the slab and cracking was found to be on both the underside and on top of the slab. Shown within appendix B is a sketch illustrating the random cracking on top of the slab at the first floor level. It is important to note that the control room under the training room is approximately a third of the size. The floor slab under question continues over another training room; however we do not have access to the soffit of the slab within this area as there are steel plates attached to the ceiling preventing a visual inspection. A portion of the floor slab directly above the control room was inaccessible as the staircase going between the first and second floor had the soffit blocked up. Consequently a hole was broken through the wall and therefore a second visual inspection was carried out, see photograph 5. From our observations temporary timber shuttering was still intact to the soffit of the concrete stair flight, however this showed signs of heavy decay due to the water ingress incurred during the wash down after training. Once the water entered this area there was no opportunity for egress, therefore causing the timber to rot. On viewing the area under the concrete staircase a build up of debris had collated and therefore it was recommended that a further survey was carried out after the floor had been professionally cleaned throughout. A third visual inspection was carried out which highlighted that numerous random cracks had occurred throughout the surface of the concrete.
