GNLRTAC Compliant Ref Noise & Vibration in Bulwell Area

Complaint summary

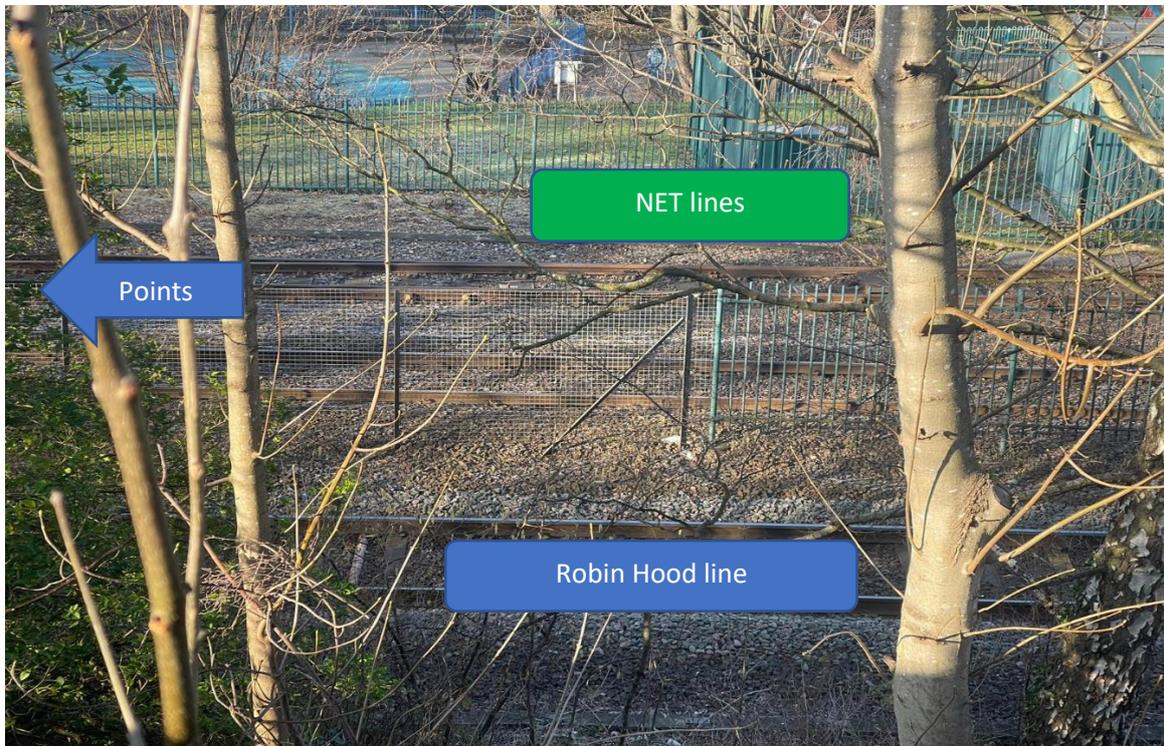
View from garden area:

As can be seen during the winter months there is limited foliage on the trees to absorb any noise so the additional trees may help. It should be noted this is not NET property until the other side of the fence.
